# ROOF SYSTEM INFRARED SCAN EVALUATION

## ALBANY HOUSING AUTHORITY

One and Three Lincoln Homes  
Morton Avenue  
Albany, New York 12202

Date: April 26, 2014

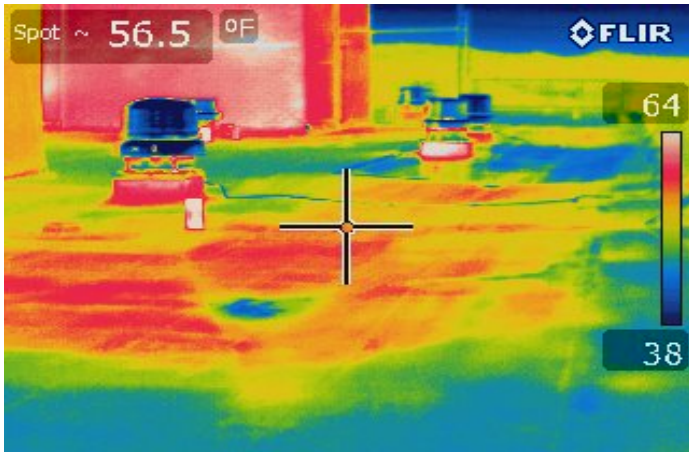
**T-1**

Overall view looking East...

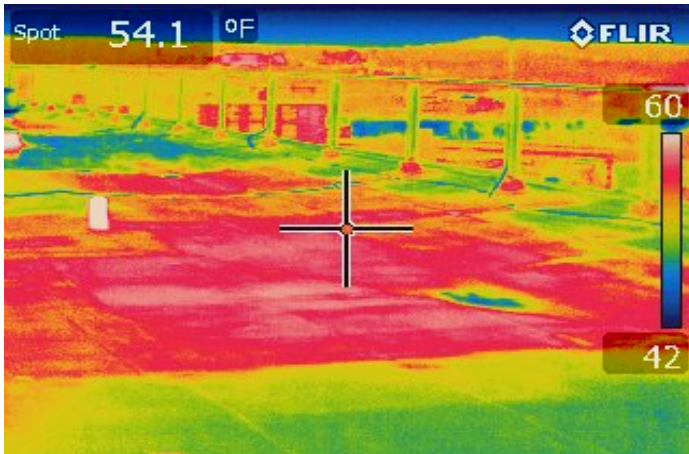
**T-2**

View of large anomaly...

3. Install spun aluminum 2-way breather vents within outlined areas of wet insulation. Breather vents to be installed every 250 ft<sup>2</sup>.
4. Lightly apply Prime-Tek 7500 Primer to prepared surface. Allow to dry.

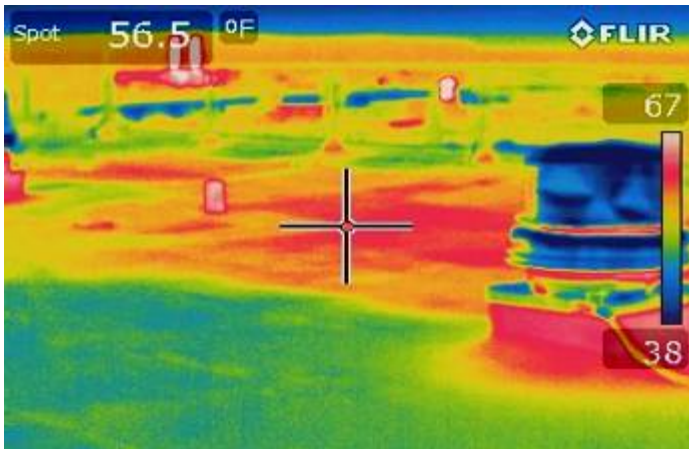
**T-3**

View looking Southeast...

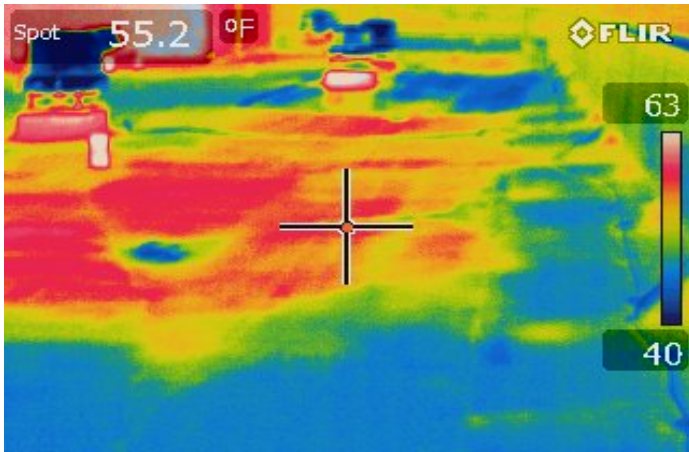
T-4

View of large anomaly looking East...

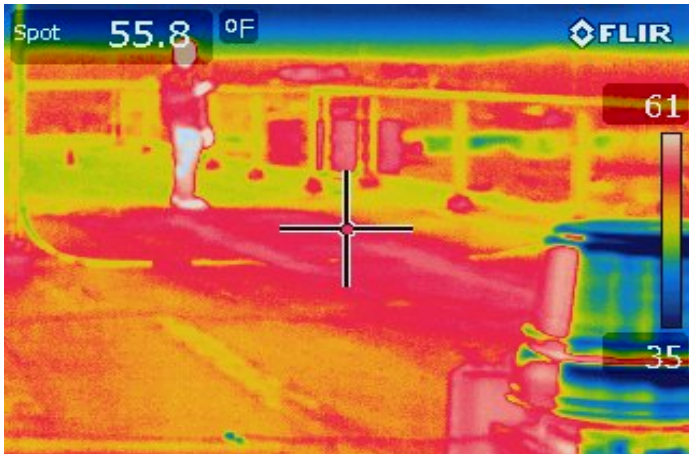
T-5

View of anomaly looking Southeast...

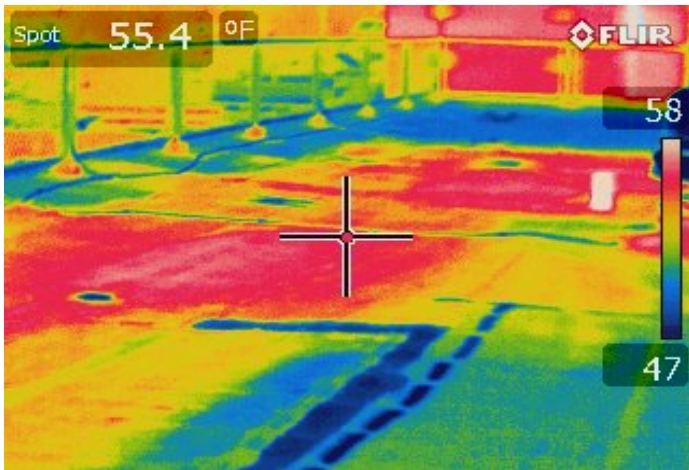
T-6

Area(s) where red are being shown were noted as being wet-to-saturated – note temperature of 55.4F° v 50.9F° for Blue, or dry area are(s) as noted

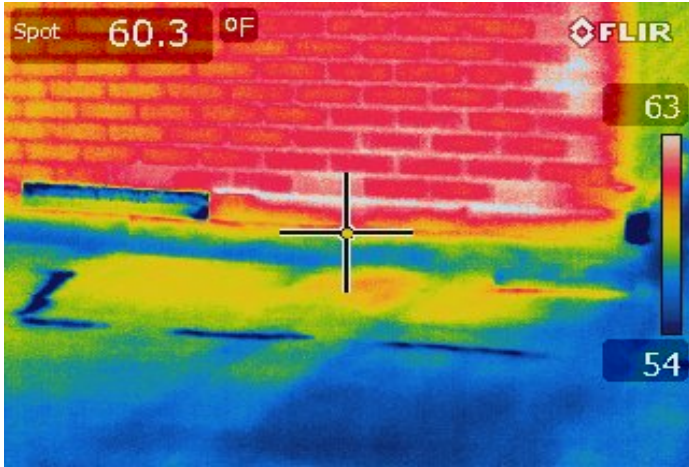
T-7

Additional view...picture framing was noted as being damp-to-wet insulation...

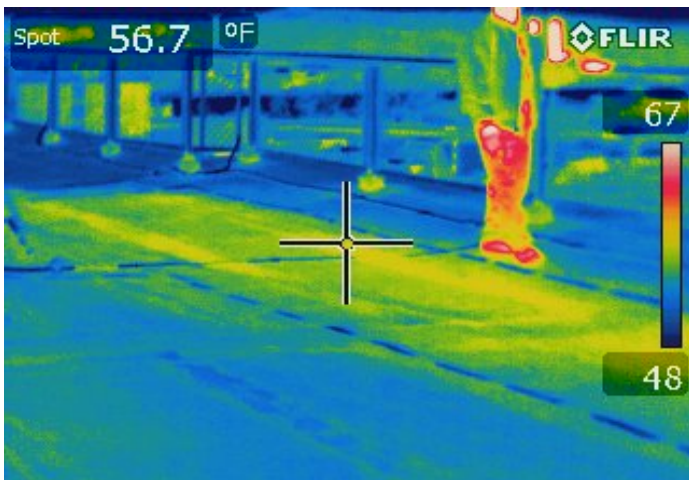
T-8

View of noted anomaly...

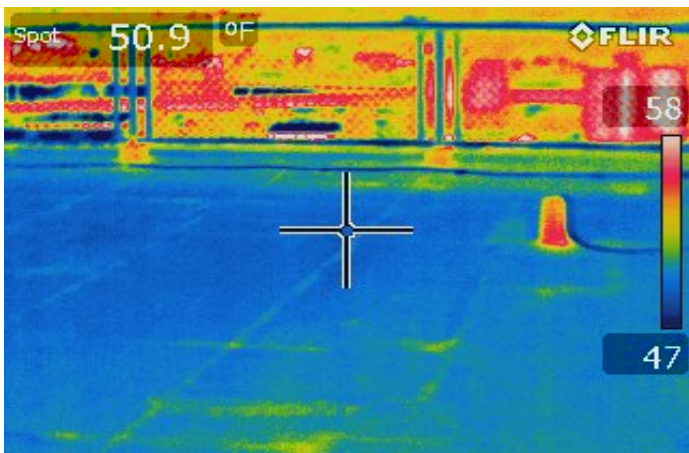
T-9

Area of dry insulation...note temperature of 50.9F°

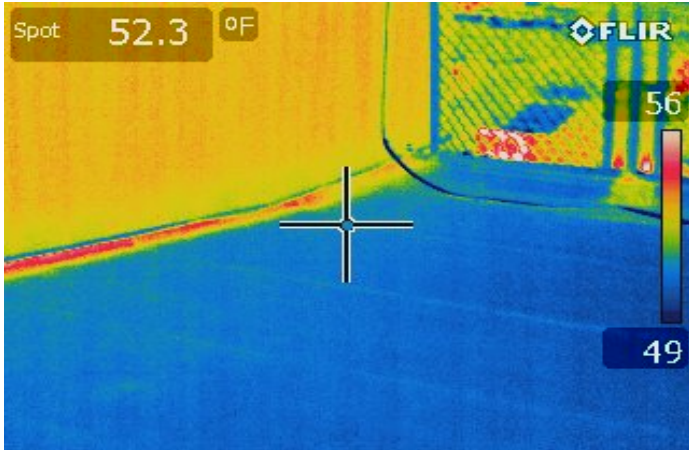
T-10

Area of dry insulation as noted near penthouse...

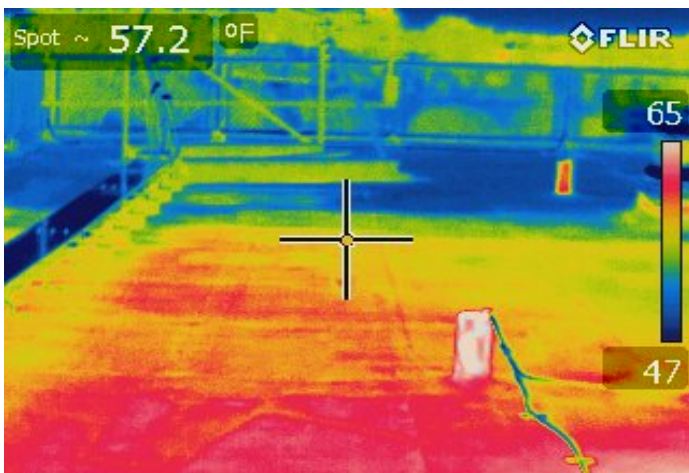
T-12

View of large anomaly looking West...

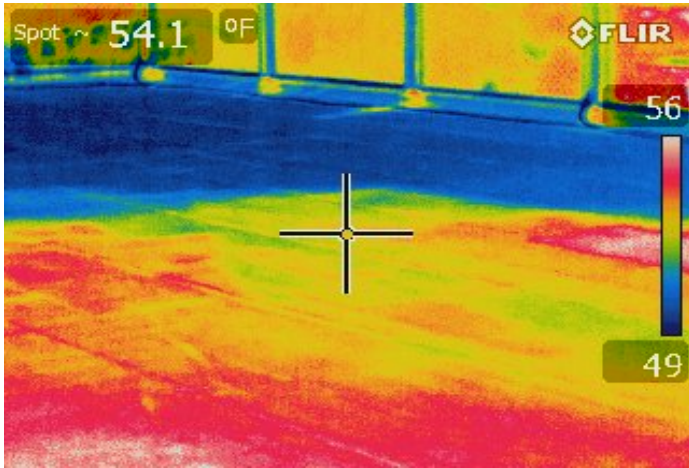
T-13

Additional view...note Yellow temperature of 54.1F°

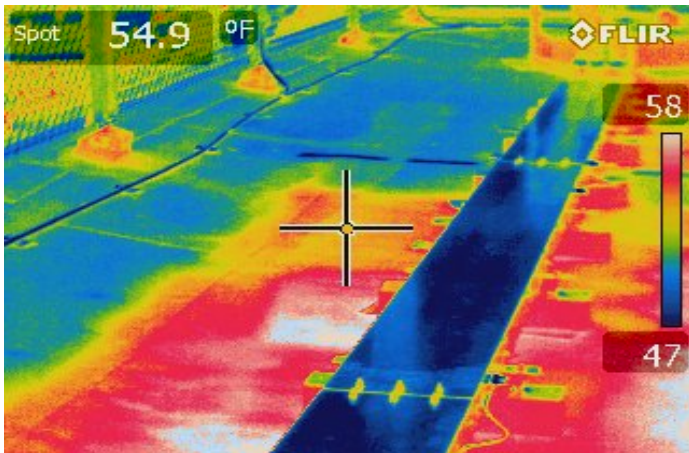
T-15

Note insulation board (straight edge) telegraphing through the mineral surfaced membrane...

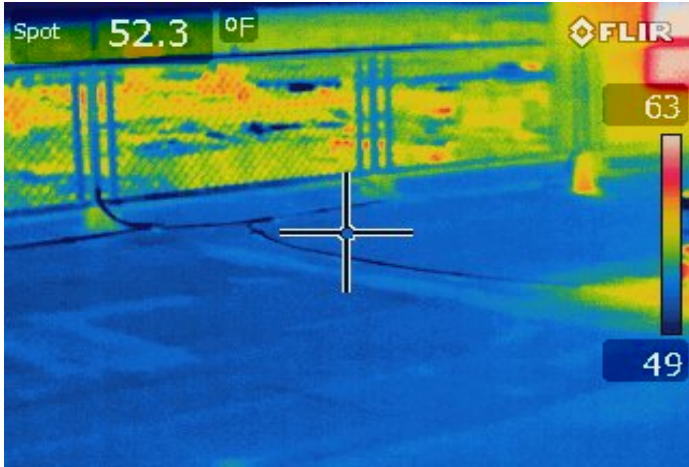
T-16

View of noted dry area of insulation...

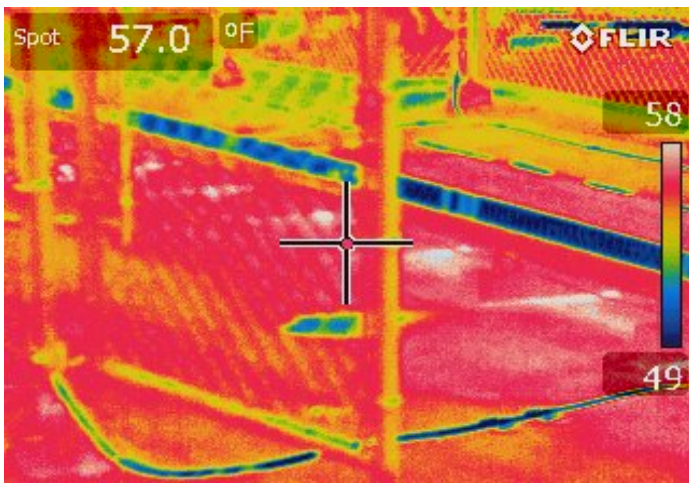
T-17

Area of wet insulation near fencing at penthouse egress...

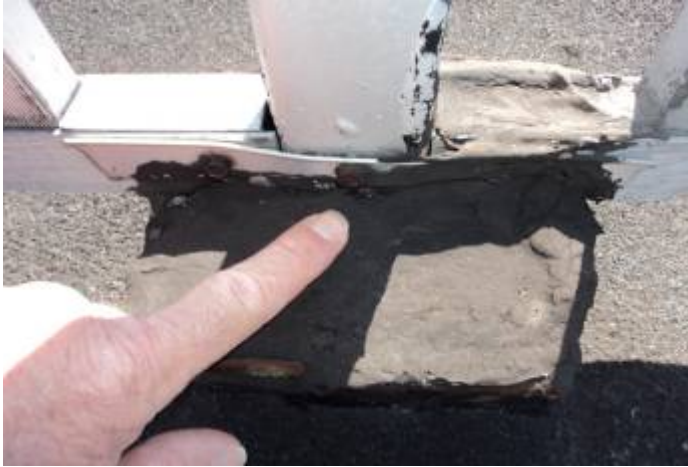
ALL PITCH BOXES WERE INSTALLED INCORRECTLY FROM DAY 1 – PITCH BOX FLANGE IS SUPPOSE TO BE PLACED ON TOP OF THE MEMBRANE, WITH THE FLANGE BEING STRIPPED IN WITH A 5 COURSE PROCEDURE...ALL PITCH BOXES NOTED WERE INSTALLED PRIOR TO THE CAP SHEET, WITH THE CAP SHEET SIMPLY BUTTING UP TO THE VERTICAL LEG OF THE PITCH BOX...ALL MASTIC HAD BROKEN AWAY ASLO AS SHOWN IN THIS PHOTO

1. Install/Retrofit new pitch boxes around existing – on side of building where wet insulation is noted only. Contractor to fabricate new pitch boxes of 16oz. copper, install on the outside of the existing pitch box, set in bed of asphalt cement, fill/top off with 1-part Pourable Penetration Sealant and strip in with 5 course procedure to a primed flange.

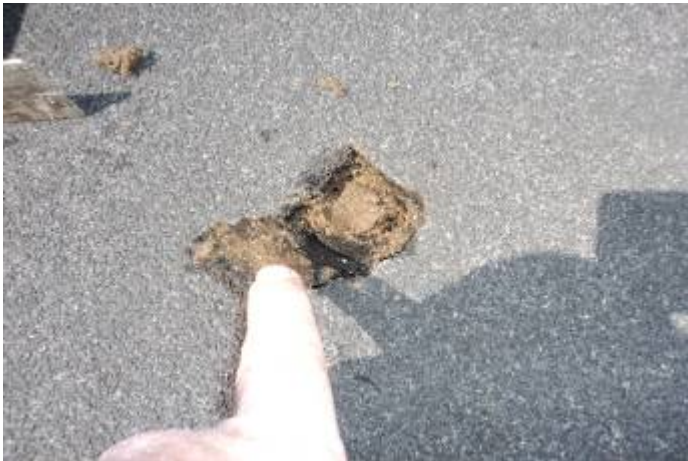
CORE CUTS REVEALED SATURATED INSULATION

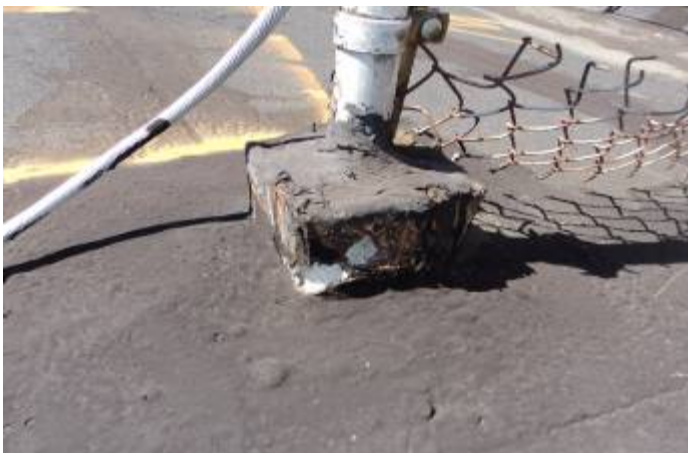
TYPICAL PITCH BOX...AGAIN, WAS NEVER INSTALLED CORRECTLY FROM DAY ONE – NOTE ASLO, DETERIORATION OF THE VERTICAL LEG OF THE PITCH BOX DUE TO LIME IN THE CEMENT EATING THE GALVANIZED METAL MATERIAL OF THE PITCH BOX – PITCH BOXES SHOULD HAVE BEEN ELIMINATED FROM DAY 1. IF THEY WERE USED, 16OZ. COPPER SHOULD HAVE BEEN THE MATERIAL UTILIZED AND SOLDERED.

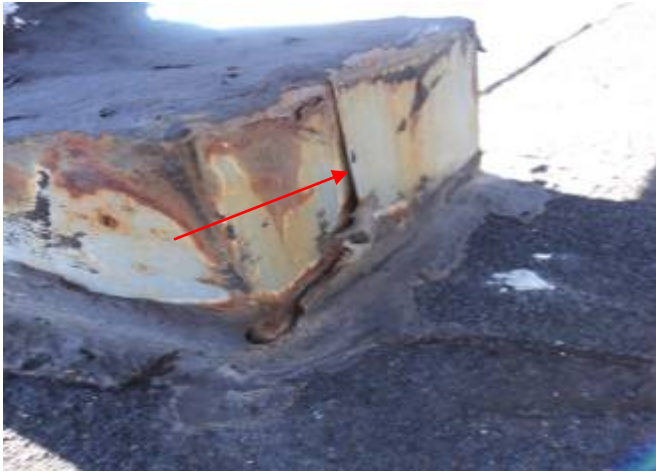
OPEN SEAMS...NONE WERE  
SOLDERED/WRONG MATERIAL USED.

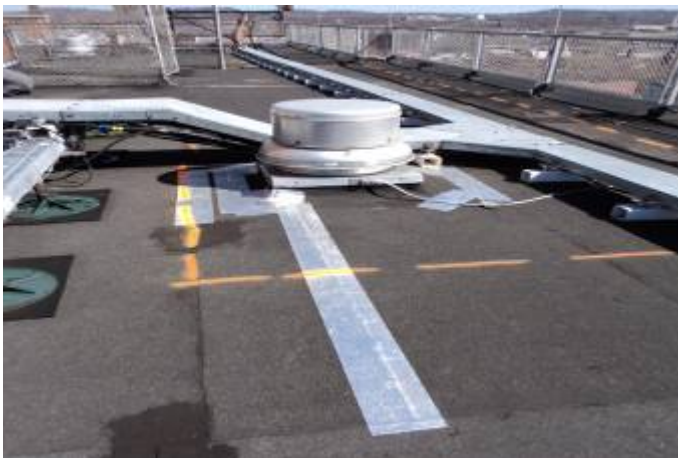
VIEW OF PAST REPAIRS...

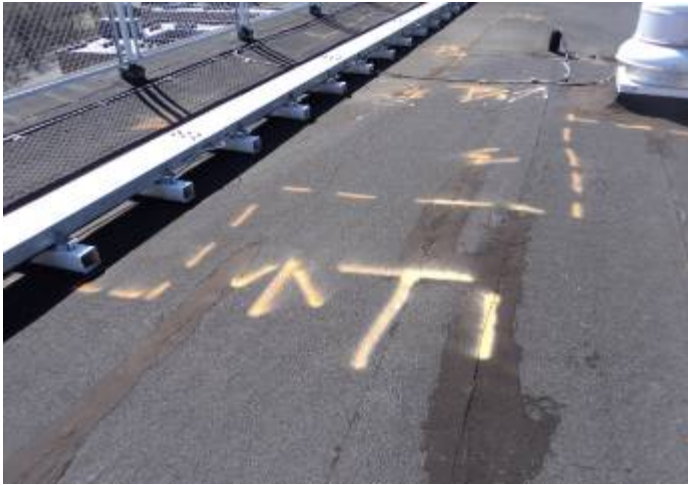
PAST REPAIRS...
