ROOF SYSTEM INFRARED SCAN EVALUATION

**CULINARY INSTITUTE OF AMERICA
1946 CAMPUS DRIVE
HYDE PARK, NY 12538**

Prepared for; Patrick Miller, Manager-Engineering Operations

Sean Moran, Roofing Innovations, LLC
Date: July 7, 2015

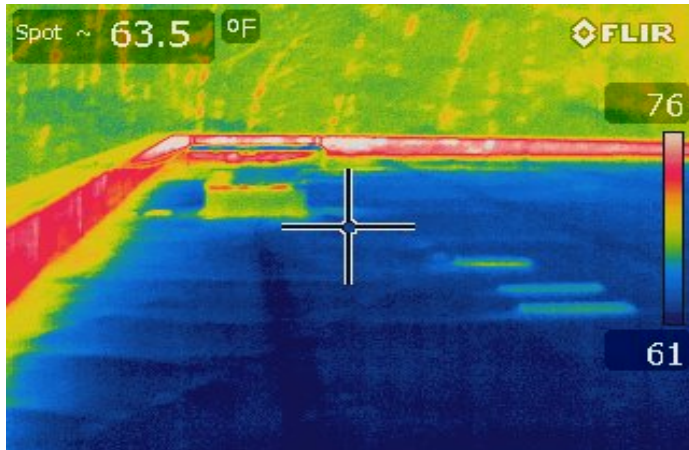
T1 - UPPER ROOF AREA...NO ANAMOLIES NOTED

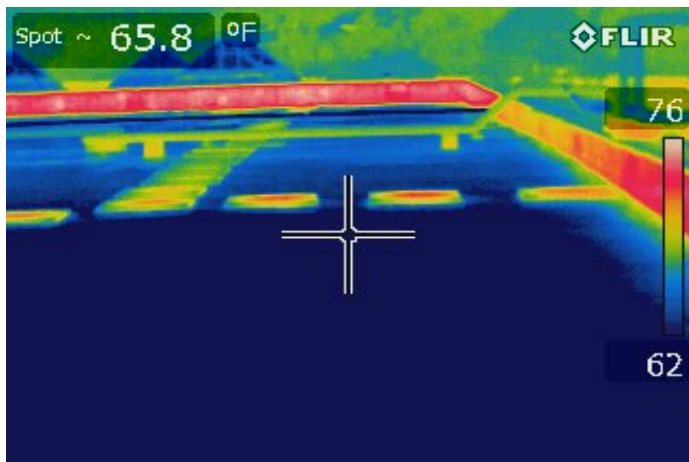
T2 - ADDITIONAL VIEW...

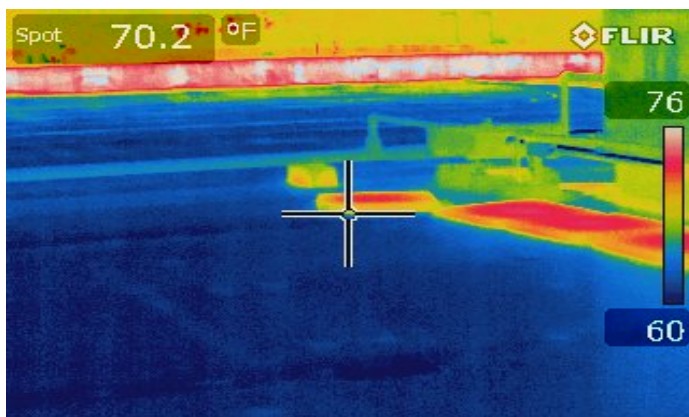
T3 - ADDITIONAL VIEW...

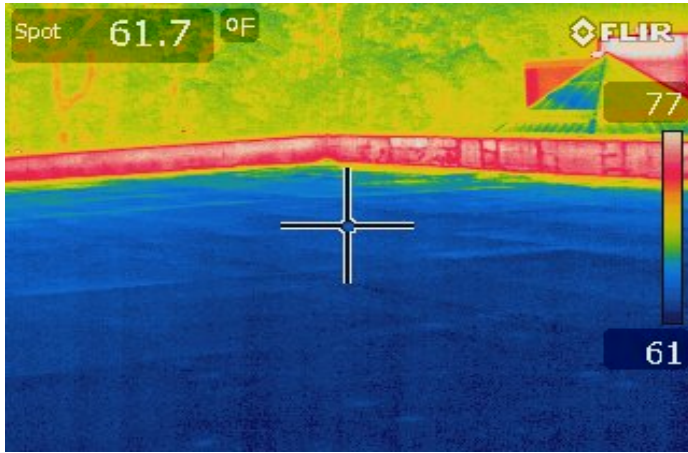
T4 – ADDITIONAL VIEW OF UPPER AREA...

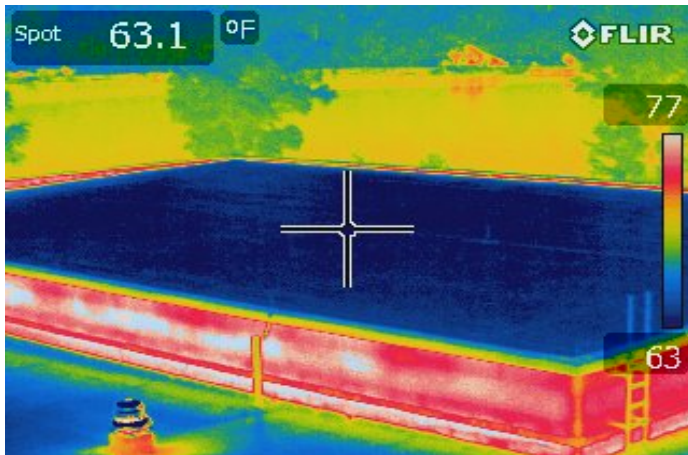
T5 – BUMP UP AREA REVEALED NO ANAMOLIES...

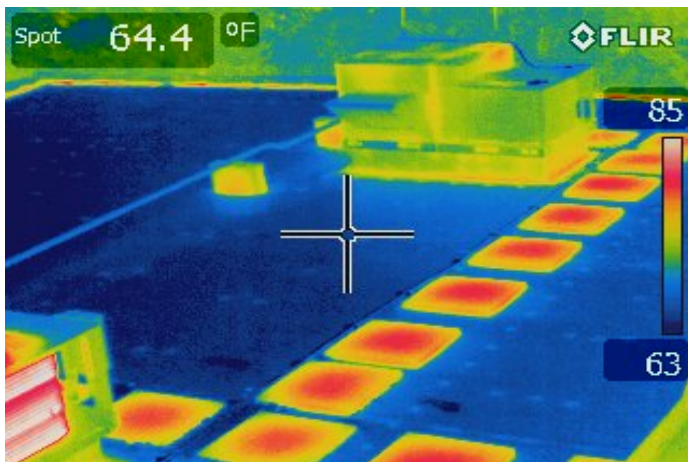
T6 – DRY...

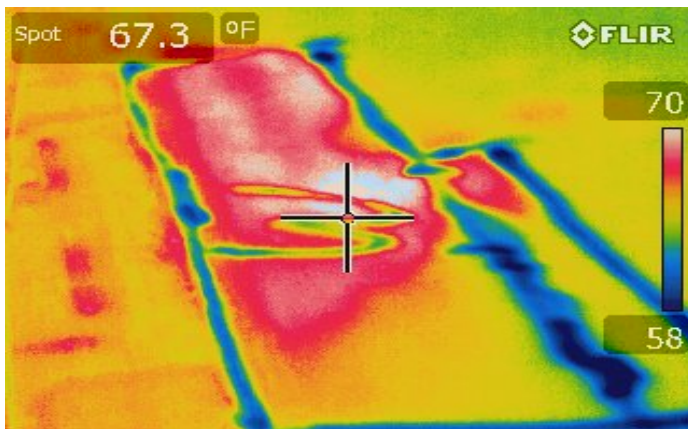
T8 – VIEW OF WET INSULATION NOTED NEAR DRAIN ASSEMBLY

In the short-term, I recommend area(s) where wet insulation is noted be repaired by removal and replacement in-kind.

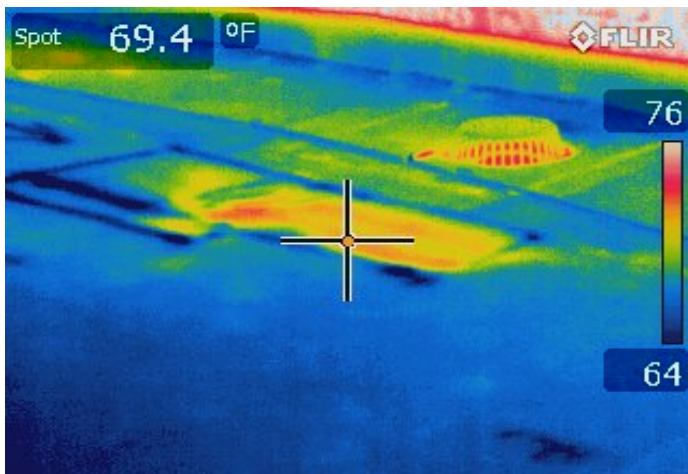
T9 – ADDITIONAL VIEW...

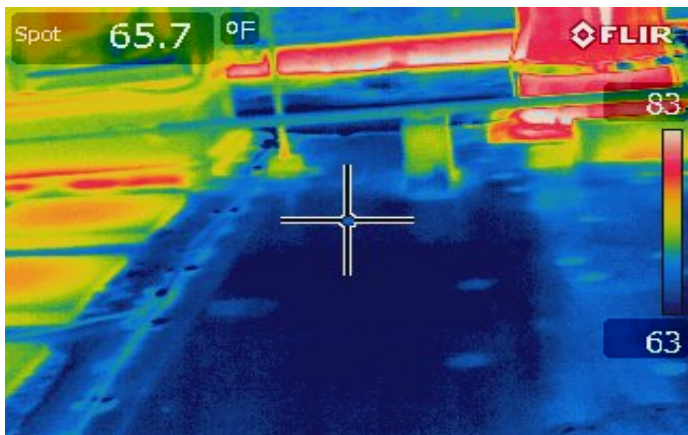
T-10 – AREA(S) NEAR ALL UNITS WERE CHECKED...AGAIN, NO WET INSULATION NOTED

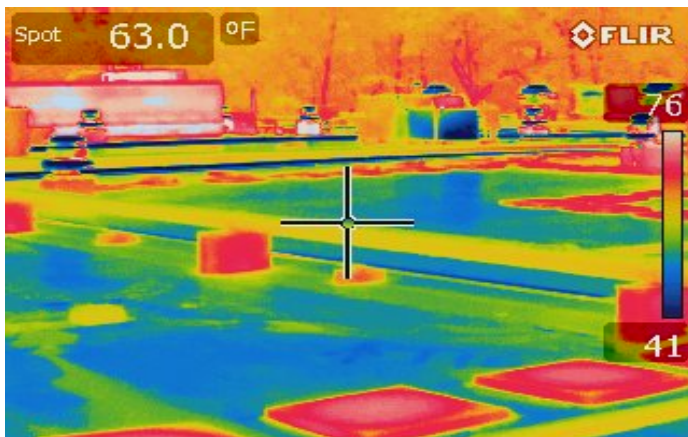
T11 – DRY...

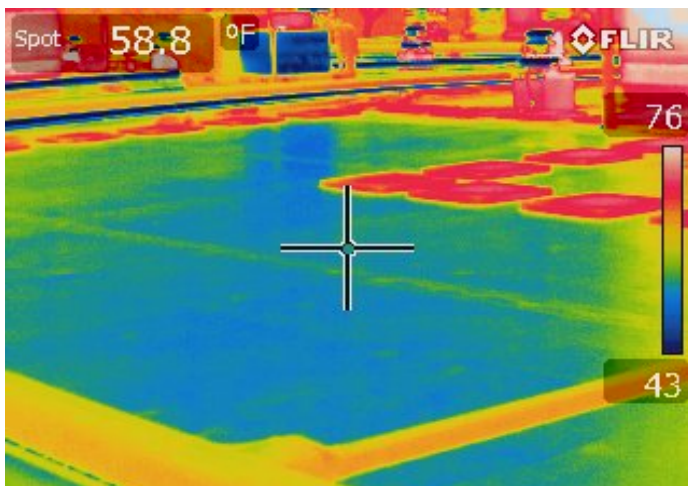
T12 – DRY...

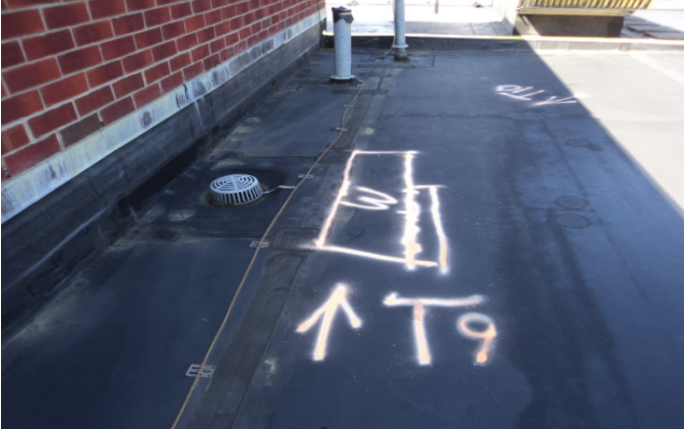
VIEW OF WET AREA NOTED AT DRAIN LOCATION...

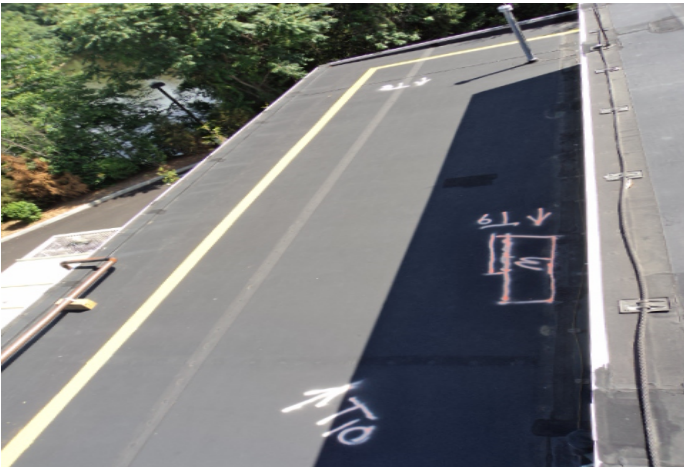
ADDITIONAL VIEW...

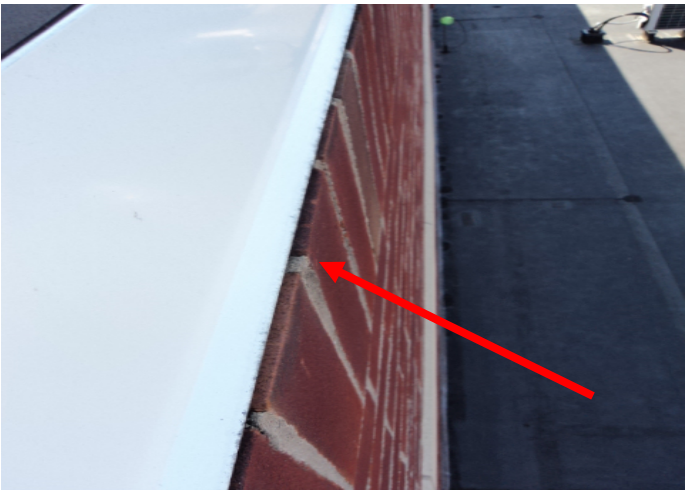
POSSIBLE SOURCE OF WATER ENTRY AT UPPER ROOF AREA...FASCIA DOES NOT EXTEND BEYOND SOLDIER COURSE OF BRICK

Additionally, where the soldier course of brick is “bumped-out” more pronounced than the surrounding area, (where the active leaks are occurring) an extender piece of metal should be fabricated and installed. The profile of the new metal will extend beyond and over the soldier course of brick a minimum of 1.5”. I’m thinking roughly 5 sections (50’ of metal) to be installed in the area(s) that are currently leaking as a trial run. If the leaking is stopped, we can proceed with completing the balance if the recommended upgrade is approved.
